“A BLOWN PISTON”

(or “The burdens of a Twin Cam owner”)

By David De Saxe

First published in “Safety fast!” March 2010

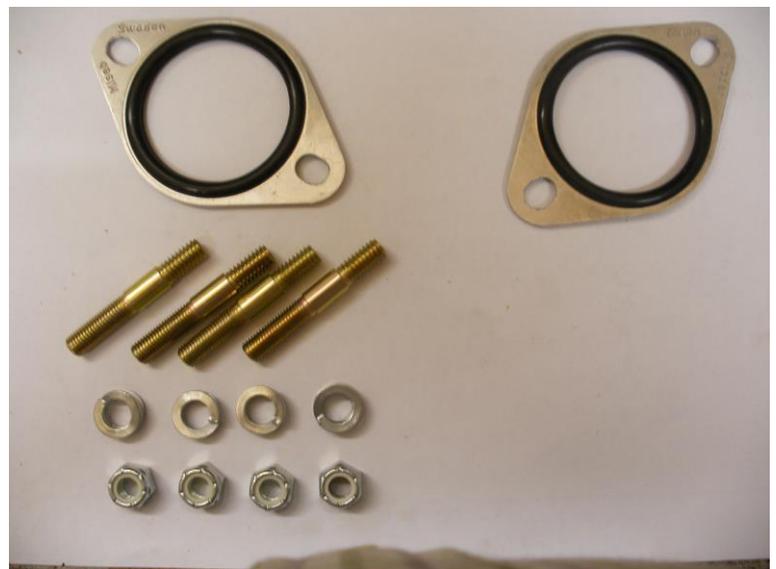
The remedy is unbelievably simple – and unbelievably cheap. For about £14+ VAT you can get the complete kit to cure the potential problem. Order the parts from Eurocarb of Reading (0118-943-1180 or www.dellorto.com). As the website suggests, Eurocarb are Dellorto (and Weber) specialists, but the carb mounting kit adapts for SUs. You can order on-line for next day delivery. You need 2 Misab 47mm. Spacers (these are thin alloy plates surrounding a lightly protruding O-ring; you'll need to elongate the fixing holes a fraction to fit the wider spacing of the manifold studs); 8 Thackery washers (these are the double wound type); and 8 nyloc nuts. (The photo shows only four nuts and washers, but you'll need eight).

When you fit them, first discard the original carb to manifold gaskets as the O-rings in the new spacers will replace these. The nuts must not be overtightened; the recommended gap between the coils on the washers should be .035 in.-.040 in. This will work well on the front carb but, because the studs on the rear one have to carry the accelerator cable bracket and the throttle return spring bracket, you can't wind the nut on far enough for the nylon insert to grip.
