Twin Cam – Poor choke operation, worsened by Ethanol

By Colin Manley

Published in “Safety fast!” November 2013

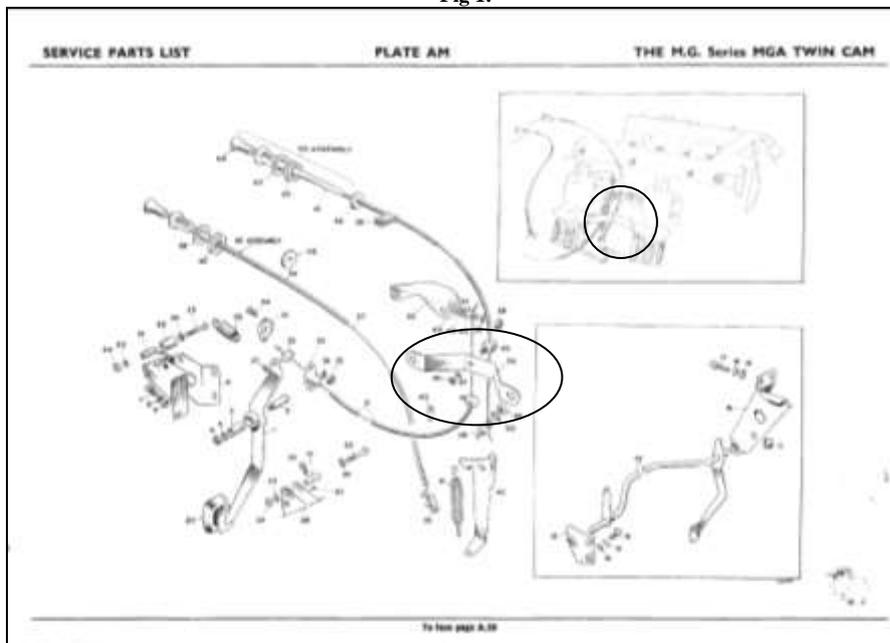
Fig 1.

The choke cable enters an Abutment (ACH5112) secured to a Bracket (AHH5828) that is itself fastened to the carburettors using the air filter bolts. The bracket is not symmetrical and the abutment mounting hole is further off centre. (Refer oval in Fig 1.)

The bracket was originally fitted in the orientation as shown in the SPL, Plate AM, with the hole for the abutment closest to the rear carburettor. (Refer circle in Fig 1.)

In reality, when the choke was operated and the cable ‘pulls up’, the front carburettor choke lever scribed an arc whilst moving vertically up to the abutment. At a certain point, further arc travel became impossible due to the vertical pull of the cable, long before full choke was achieved. This also exerted a side pull action on the lever making the jet tight. The 2 different jet levers appeared to be fitted to the correct carburettor, but no way were they being operated fully.

If the choke cable was presented in such a way as to pull in the same plane as the choke levers needed to move, operation would be corrected. Looking at the Bracket it became apparent that if it were rotated 180 degrees, the abutment would move closer to the front carburettor, enabling further arc travel and thus, operation of the choke on the front carburettor whilst not impeding the choke operation of the rear carburettor. The cable presentation angle would also be corrected. 5 minutes later, the bracket was rotated - the choke operation is now so smooth and full choke operation is easy. Now, just a pull on the starter results in an instant start with hardly any turning over of the engine at all.

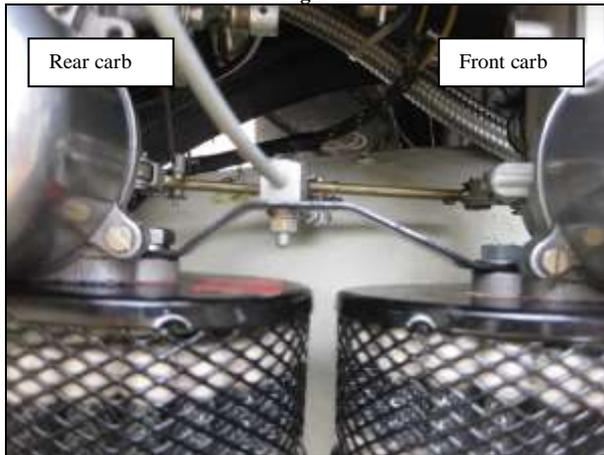
Fig 2.

Figure 2 shows the choke cable bracket as originally fitted, supposedly correctly. This prevented full choke operation and also put a side load on the front carburettor jet preventing smooth needle movement. Hence the splutter on start up as only one carburettor was on choke and the other carburettor, the needle was tight due to the side load being applied to the jet.

The original angle of the choke cable was not perfect, but on non Ethanol fuel was sufficient for a cold choke start. Ethanol in fuel has affected the fuel burn and the combination of Ethanol fuel with a poor choke operation (i.e. not full choke) as a result of poor directional alignment of the cable caused the bad cold start.

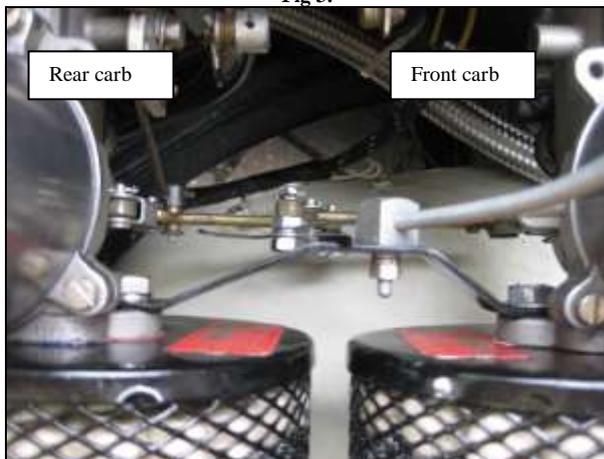
Fig 3.

Figure 3 shows the choke cable bracket once rotated and the abutment now presenting the cable correctly. The front carburettor lever now pulls up fully, its arc of travel takes it towards the abutment. There is no side load applied to the jet and needle movement is free.

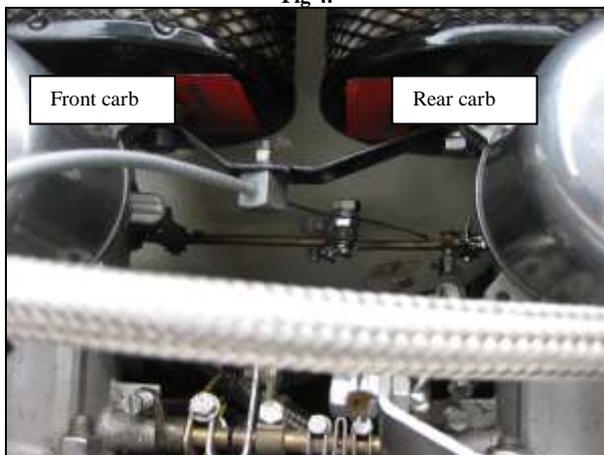
Fig 4.

Figure 4 (taken from the other side of the engine) shows the angle of the choke cable now, with the abutment closer to the front carburettor. A final improvement will be to mount the abutment slightly further to the right (as viewed) – almost dead centre of the air filters, to give an absolutely ‘parallel pull’.
