The Flex Plate and Vertical Drive.

An article Inspired by Bill Bollendonk who is negotiating his way through an L rebuild.

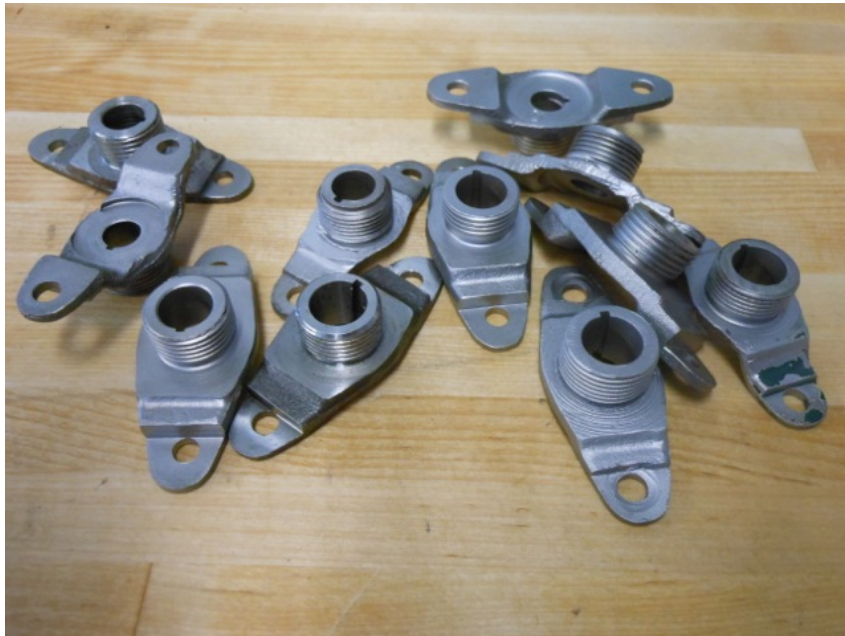
A careful look at both new and old forks assembled below show some that are relatively flat and others whose forked ends are significantly offset.

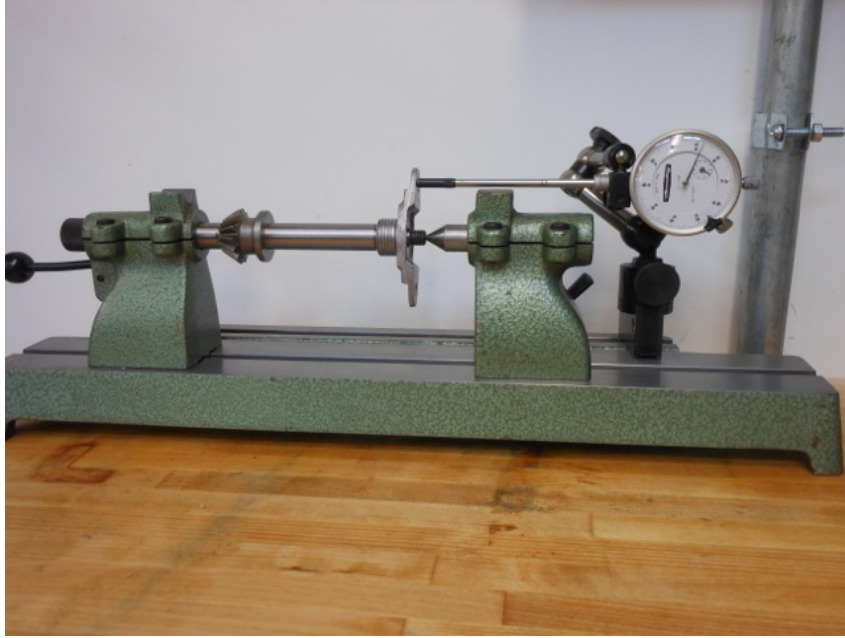
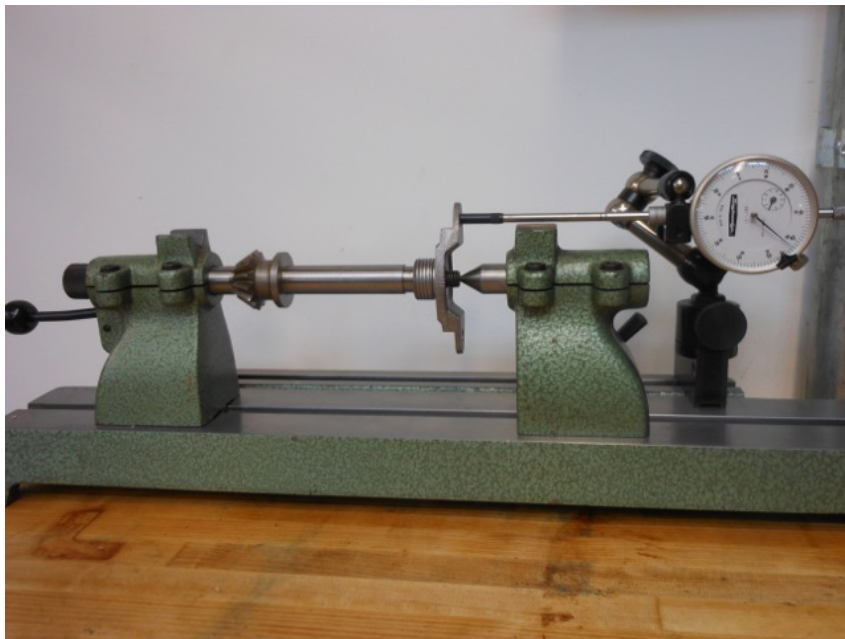
In addition to these varied offsets, the tapered bores vary significantly and will position the forks in different locations on the shaft. Notice the variations in fork positions on the two pictures below. (The shaft is new and the two forks are new.) The first picture will yield an assembly which is .210" shorter than the assembly in the second picture. This information would prove most helpful should a longer or shorter assembly be needed.

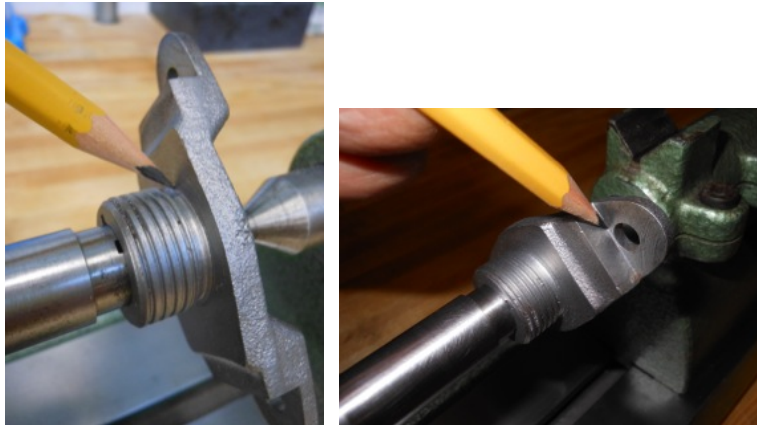
Over long use and/or mis-registration with the generator drive, the fork will fail in two areas: 1. At the base of the scroll. 2. In the area under the D-head bolts. Failure usually occurs in these locations as a fault of a marginal or no radius machined into the fillets.

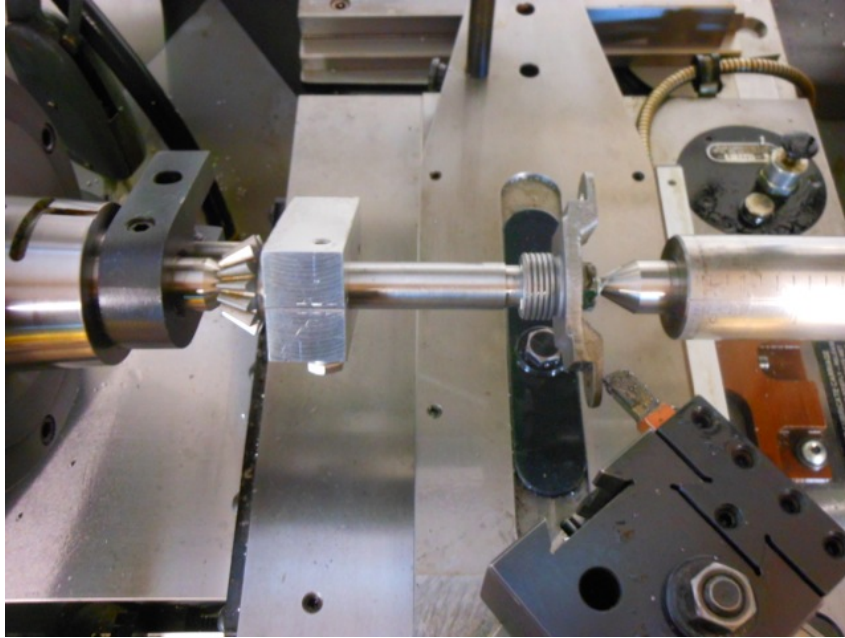
With the potential of the fork and shaft now to be mated as an assembly, there is still no assurance that the plane of the fork is perpendicular to the axis of the shaft. It most likely is not, especially if the chosen components are new. To address this issue, and it is an **IMPORTANT ONE** to address:

3. Assemble between centers on a lathe with a suitable dog drive and machine the face of the fork as seen below. **Note:** It is recommended that if the generator was finish assembled to the front housing and the head fitted to the block with a gasket of appropriate thickness, the distance between the generator fork and the vertical drive fork could be measured and the fork machined to the thickness of the flex coupling swaged collars.

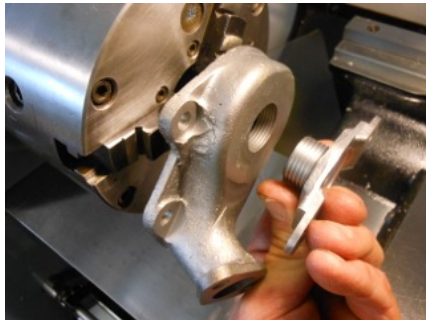
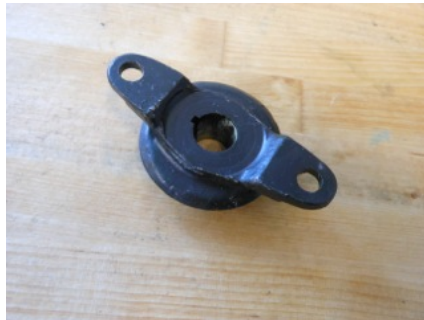
Before removing the fork from the shaft, it is wise to reflect on oil control. Traditionally, oil accumulating in the housing above the generator would overpower the reverse acme threads machined onto the fork. Misalignment and loose assembly would compound the problem by imparting matching grooves in the upper casting making oil control nearly impossible. Remedies in Great Britain would include soldering a disc to the underside of the fork to act as a slinger to shield the generator but create a spray of oil around the engine bay and inside bonnet.

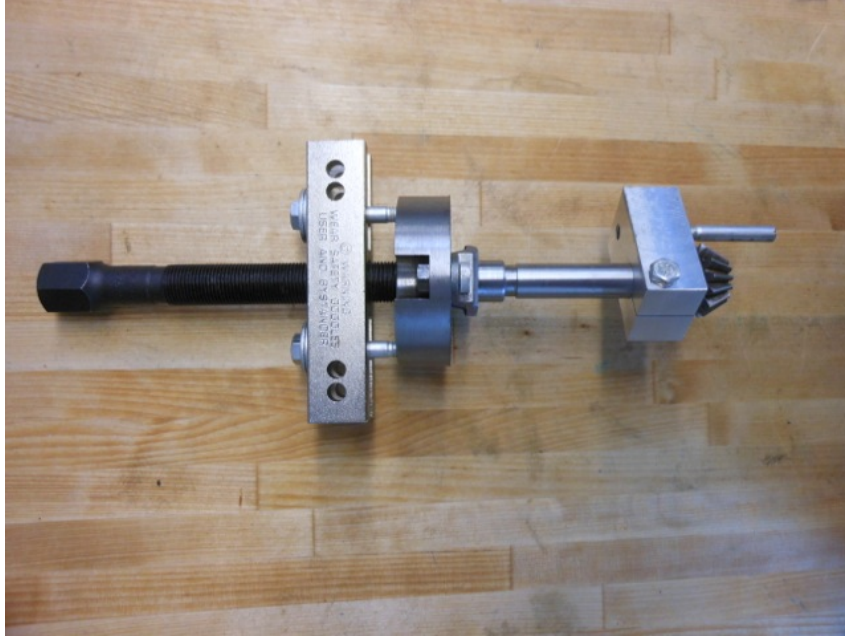
The efforts to create an absolutely true shaft and fork assembly can be ruined without one last precaution. It is often seen in practice to pull the fork off the shaft using a dual armed puller engaged to the two ends of the fork. With the fork tight on the shaft, this will likely bend the ends of the fork inward, and thus negate all mentioned previous efforts. A far safer and best practice would be to engage the use of an intermediary disc that would bolt to the fork to keep the arms in the same plane and then use a puller pushing through the center of fork to release the fork from the vertical shaft. The fork will pop off the tapered shaft and no damage will be incurred to the fork arms.
