Side screen brackets on the MGA Roadster

Geoff Kirk

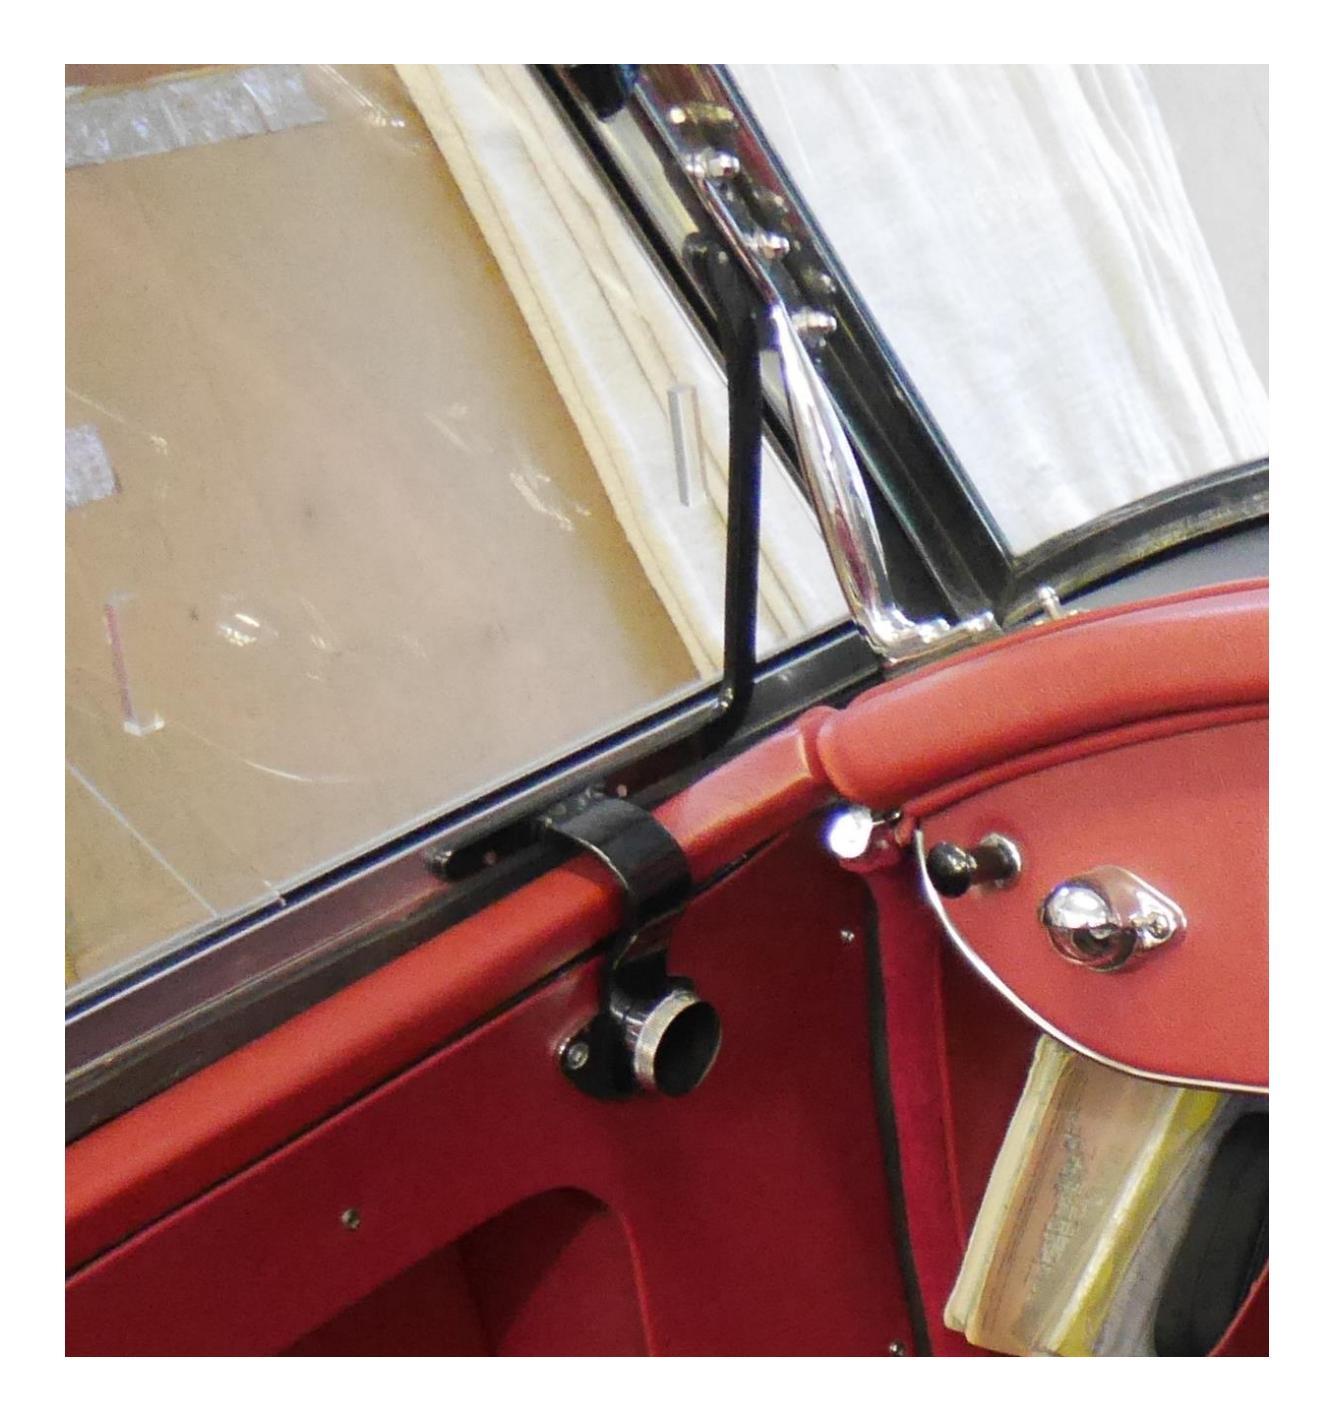
Close up of the finished job. The screen bracket clears the cockpit rail, the screen tucks into the side of the windscreen frame and the top of the support bracket misses the grab handle.

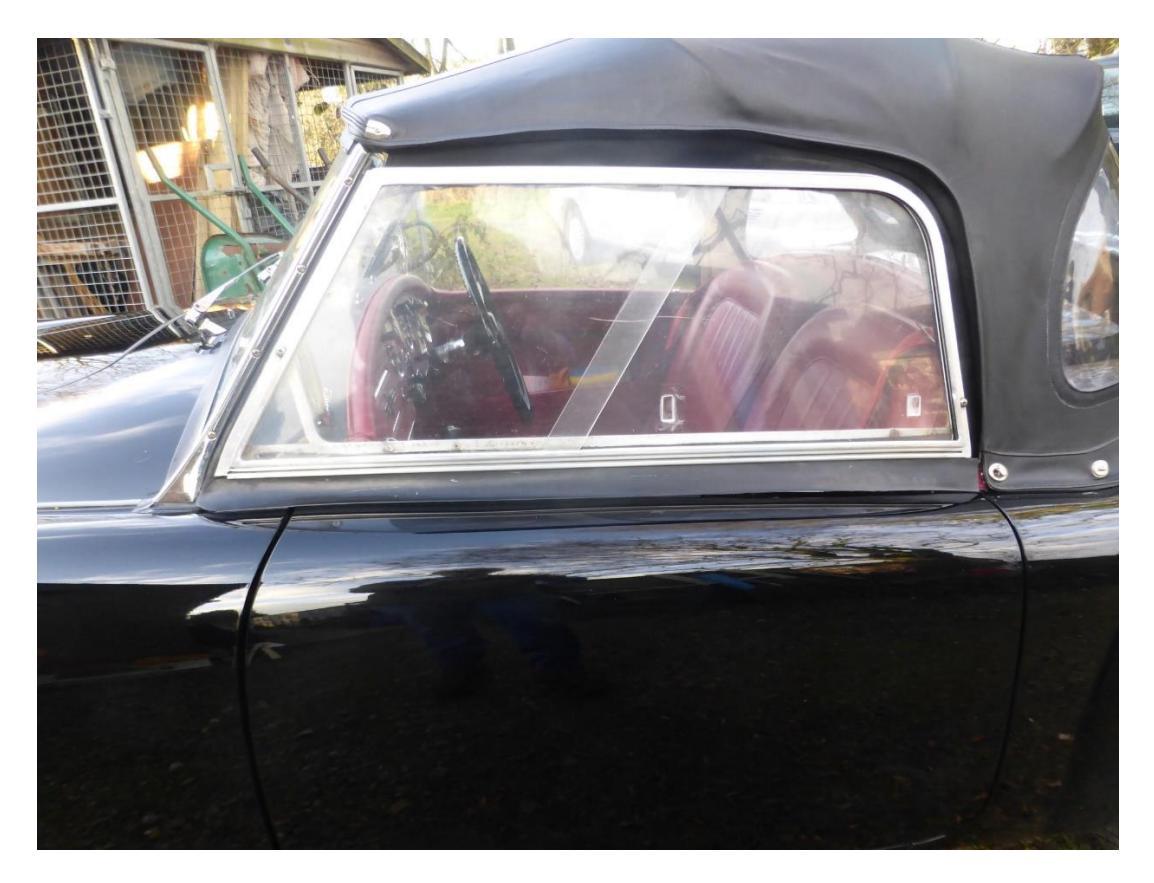
Side view showing that the screens tuck into the windscreen stanchion, as finished.

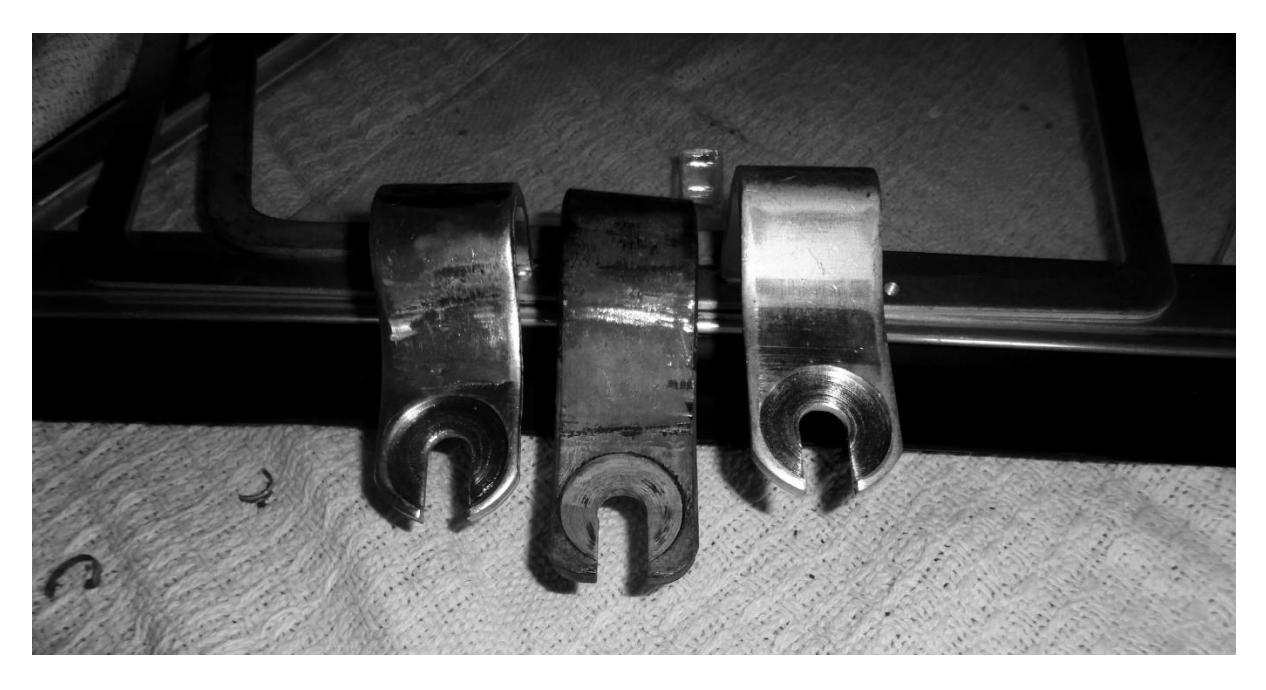
On comparing with both the original fabric screens and the original "Weathershield" ones it is quite clear that the front brackets on the new alloy screens are different in shape.

Comparison of original stap bracket to repro supplied items. Original bracket strap in the middle, modified replacement to the left and as supplied strap bracket to the right

My first attempt at rectifying the new brackets was to re-form the shape using a "scroll tool" created from two pieces of round bar socketed and welded to a base. The resulting bracket was a better fit but still forced the bottom edge too tightly onto the leather covered cockpit rail and didn't alter the fit to the front edge / windscreen.

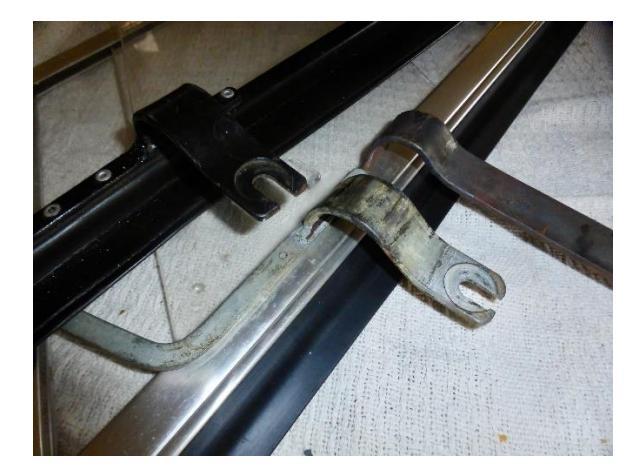
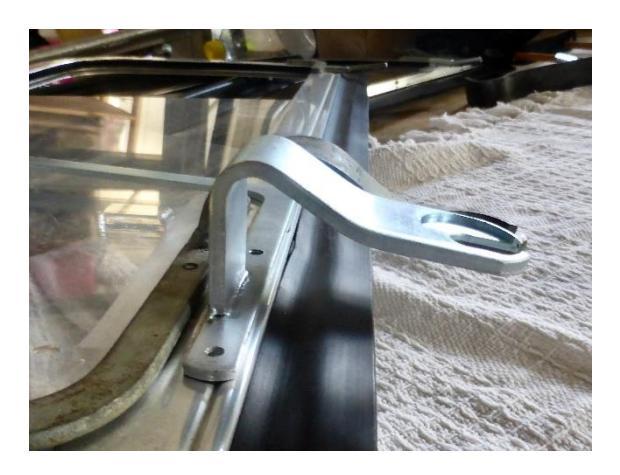
Original brackets used as a template when forging the replacement. The bar used is as original BMS 5x30. On the right, the new bracket welded to its mounting plate

The process to make new screen brackets started with the correct section steel, 5x30 & 5x13 BMS black mild steel has that rounded edge, like the originals,) . Nick Moore, blacksmith at Market Weighton, had the section in stock which he kindly gave me a couple of short lengths.

I first bent the swan neck of the door strap using the scroll tool and heat. This created a similar form to the original ones, then a slot was drilled and cut by hand, (I haven't got access to a milling machine to form the recess to accommodate the knurled doorknob).

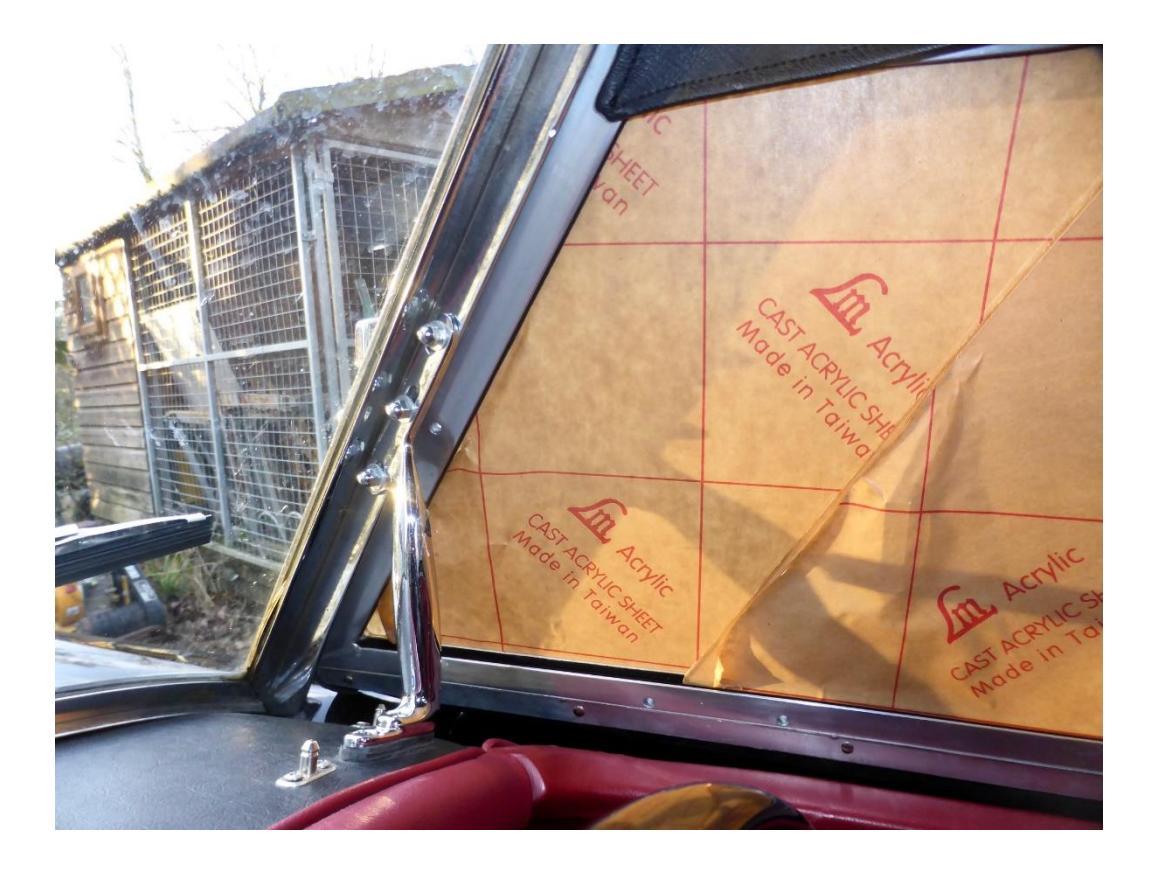
The pains taking process of aligning the front of the side screen to the windscreen

Having now attached the strap to the screen the whole screen was again positioned in the opening and the door swan neck offered up and marked for tack welding. The assembly was then adjusted until a satisfactory fit was achieved and finally fully welded up. The rear bracket and peg were then fitted and welded in much the same sequence. The fit achieved was satisfactory except the top to hood gap was still too large as the hood really needs fitting to the side screens. The final tweak was the addition of a short piece of petrol hose to the door locating peg to lift the angle of the front edge of the screen to fit into the windscreen stanchion.

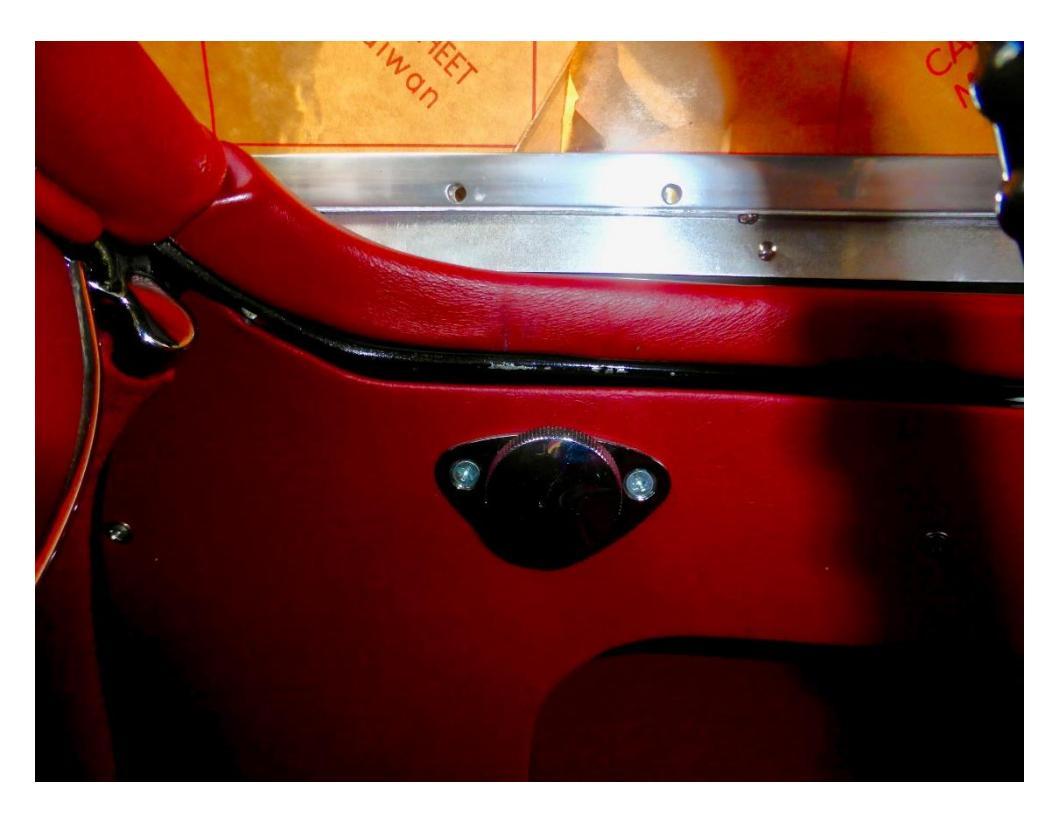
Mounting pad on the door frame, on my car is in the original holes, the door card is a single layer of GRP reinforced across the door pull with a 25mm woven tape; the plus of this is that it allows more space for the door seal as it is considerably thinner than the Mil board replacements that are usually supplied.

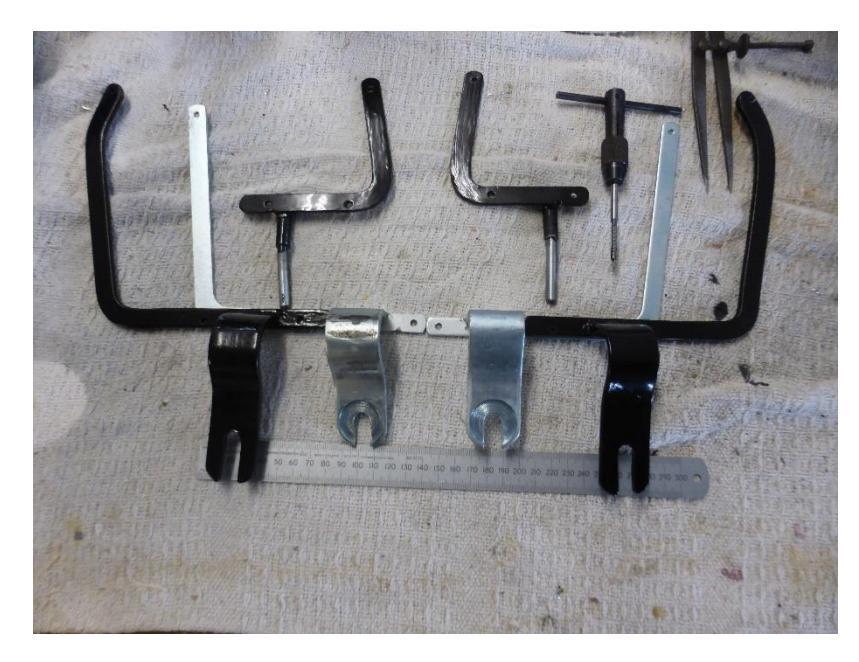
Brackets as made compared to the ones supplied. Notice they are too short!
