MG TA Tickford Rebuild Project

Martin Curren describes the rebuild of his TA Tickford which he has owned since 1968

**MG TA chassis number 3184, engine number 3442,
Tickford body number 4674**

**MG build date 13th March 1939, Salmons &
Son build date 15th to 21st April 1939**

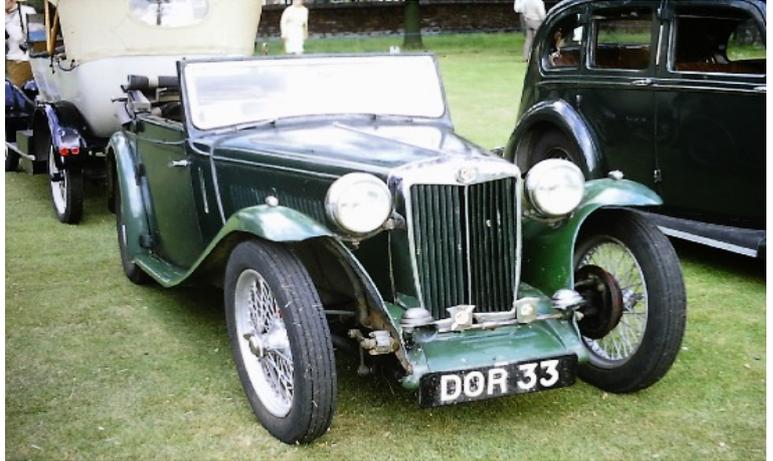
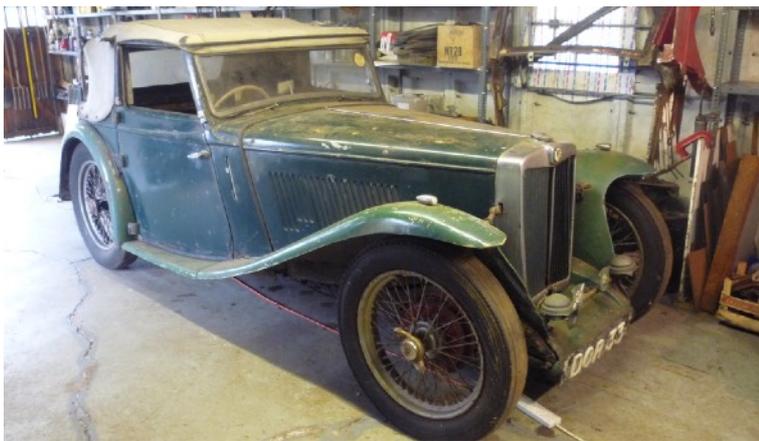
This is the car before it was dismantled in 2010

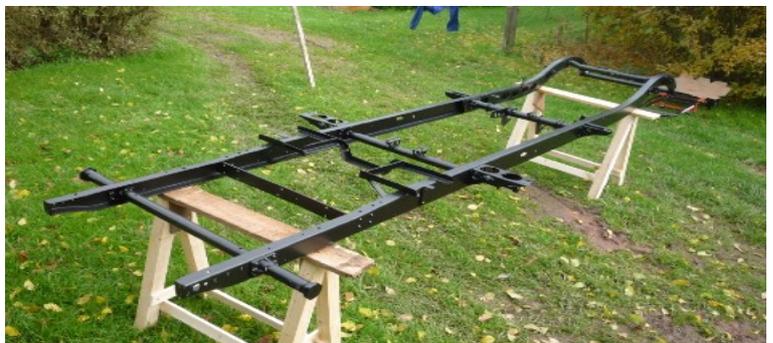
The Tickford has an additional metal sub frame mounted on the chassis and bolted to the front, and rear outriggers plus additional mounts bolted each side adjacent to the front hand brake cable mount. These brackets are handed with the nearside one allowing for the two petrol pipes to run through it.

The subframe on my car was badly corroded and needed quite a bit of new metal welded in to certain parts. I made up a wooden jig to keep the shape correct while I made the repairs. This frame provides the essential shape for the rear wheel inner arches and acts as a mount for the wood frame uprights for the bulkhead, the door posts and the wood over the rear arches.

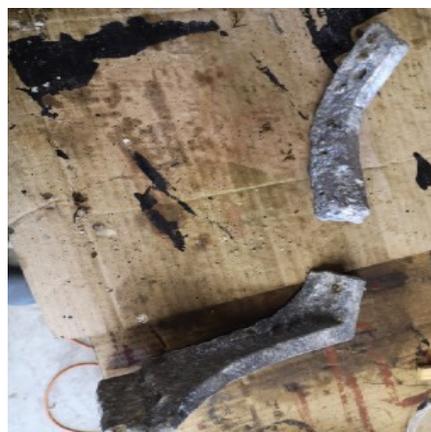
An old rear body bracket

Progress then slowed down. The Tickford has two key brackets that form the curves at the back of the body tub bolted to the metal sub frame. These are made of aluminium and the brackets on my car had almost corroded away because when you have steel and aluminium in contact

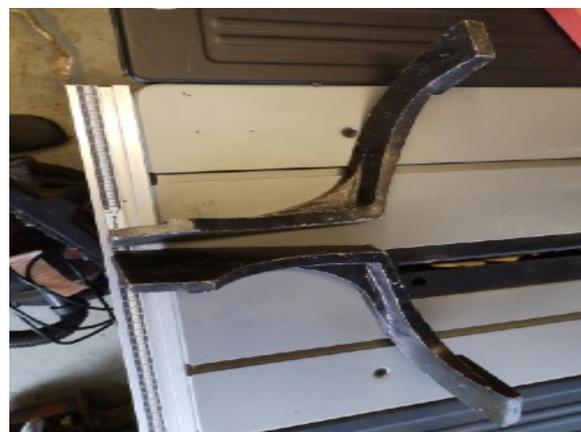
A pair of new aluminium body brackets

it is the latter that suffers the most. I had to find a source for some new brackets. Eventually I located a

small company in Bridgnorth who were prepared to have a go using what was left of my old parts as a pattern. Initial attempts failed to get the right shape but eventually they got it right. However it took the best part of a year to get them made. I also got the alloy pieces that act as rear mounts for the subframe cleaned up – these also support the petrol tank.

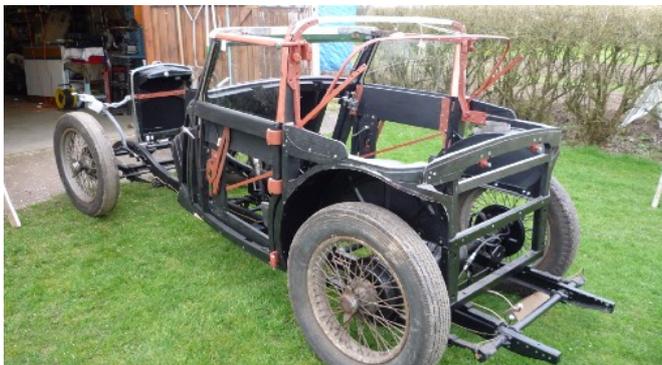
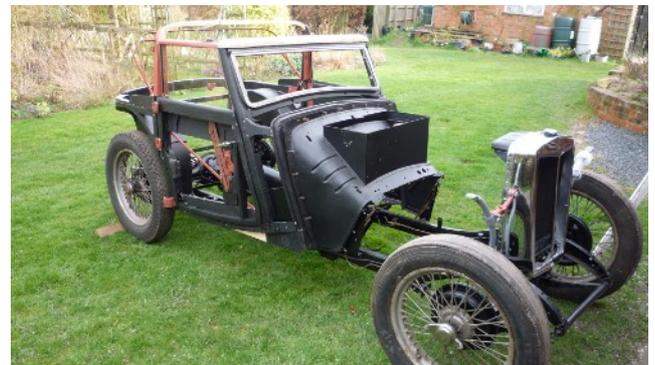
The body frame nearly finished, just the third hood bow to make

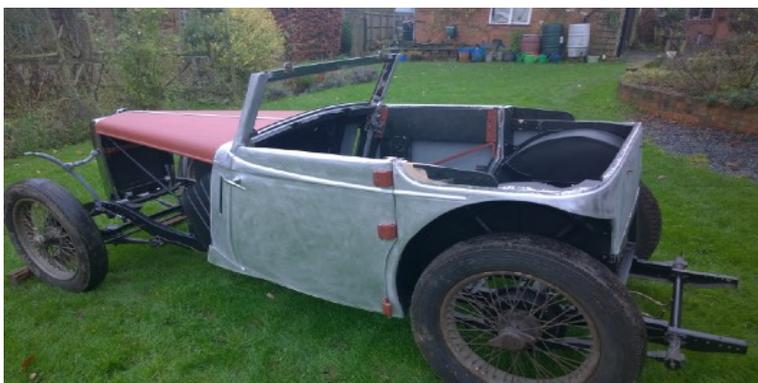
In 2014 I felt the body was ready to be skinned and I looked for a specialist who could undertake the work, preferably not too far away so that I could keep an eye on it and sort out queries if they arose. I was fortunate to find David Cale who runs Cales Specialists just outside Worcester. David learnt his trade at the Morgan factory and has set up his own workshop specialising in bespoke bodywork. He had not worked on an MG Tickford before but was confident he could do the job based on the frame I had built and a variety of patterns and pictures that I have. I had to wait nine months for him to be able to fit it in but I'm glad I waited because he did a great job re-skinning the complete tub and doors in aluminium. We discussed whether to do it in steel or aluminium and I opted for the latter to

save weight, particularly for the doors, and also to limit future corrosion. He managed to get the swage line down each side lined up well with the bonnet tops. The bonnet tops are also unique to the Tickford, slightly wider at the scuttle and with a swage line down each side.

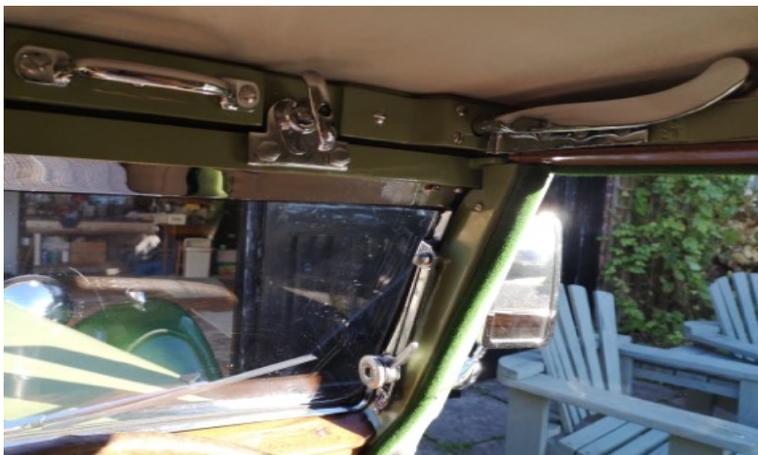
Some of the chrome parts associated with the windscreen and hood

which are chromed. In total there are 28 individual chrome parts associated with the hood in addition to the external beading and the rear window.

All these parts were cleaned up and checked for fit and about 80% needed to be re chromed. I had the radiator surround repaired and re chromed by S&T in Bristol but I opted to have all the other smaller parts done by Castle Chrome in Dudley. Both did a good job. At this stage I also needed to get all the rubber parts most of which came from the MGOCC but some, being peculiar to the Tickford, I sourced elsewhere. This included the seal at the top of the windscreen and the seal that goes around the windscreen frame itself. Woollies and Phoenix Trim both have extensive ranges of rubber seals and other bits of trim I also used them for the window channel felt used in the door windows. I also needed the special grommets that fit in the bulkhead to seal the wiper spindles. I thought Y type ones might work but Pete at the Club dug some out and they were the wrong size. He very helpfully pointed me in the direction of Paul Beck and they had what I wanted. They were also able to supply window winder handles very similar to the originals. I also needed the correct door handles (my original ones were not right) and I sourced these from Peter Radcliffe in Hull who was still running the SVW business at the time.

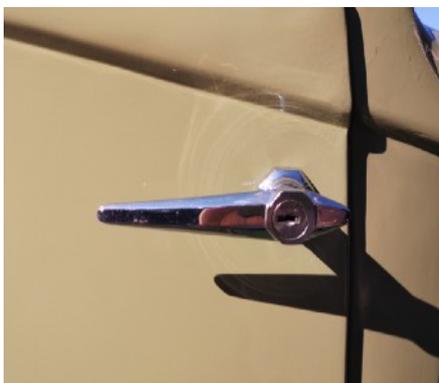
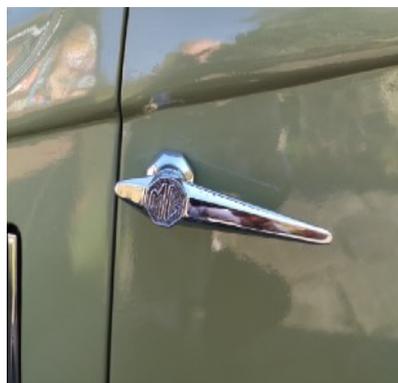
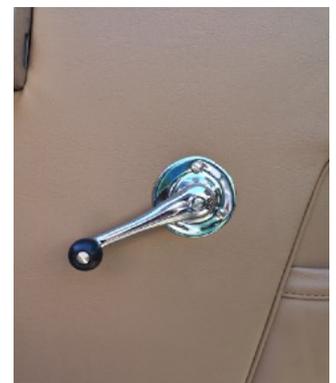
The drivers door has a lock and the passenger door has an MG logo

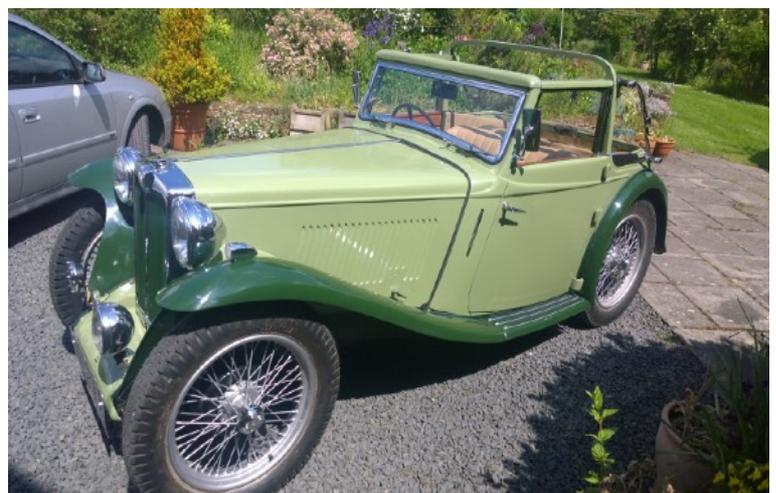
The car with painted tub and panels

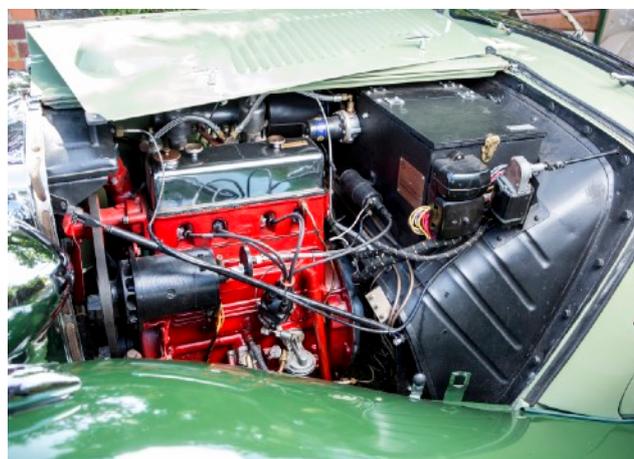
The under-bonnet wiper motor next to the control box

The Tickford has the same electrical set up as the standard car with the addition of semaphore style trafficators fitted just in front of each door, an under-bonnet wiper motor driving individual wipers via a series of cranked arms under the dash and an interior light fitted on the hood bow just above the rear window. So I installed the new looms – both the dash and main loom – and first of all wired up the dash and fitted all the instrument panel lights. I then added extra wires for the trafficators, the wipers and the interior light. To reduce the load on the old third

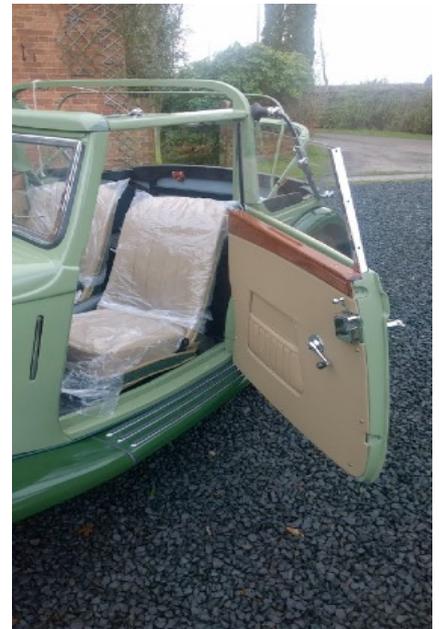
made new wooden bases but the seat backs and hinges are steel and they were fine after a coat of paint. The spring backs were also good to use again. The base and front of the seat back are trimmed in leather but the rear of the seat back is trimmed in carpet. The trim is attached to wood strips attached to the outer edge of the seat back and I had to make new wood strips for both seats. I had the seats and door cards professionally trimmed in leather. The carpet is Wilton produced in small quantities by David Tankard to the original patterns and colours available in the 1930's. In my case it is green with a black fleck. David has been an avid collector of Tickfords and Tickford parts and it is sad to know that he is now not well enough to realise his dream of driving a finished car on the road.

Newly trimmed seats and door cards

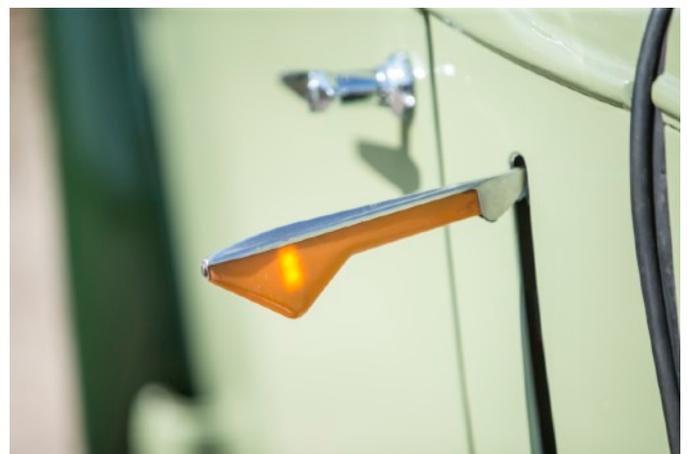
The trafficator acting as a side repeater

like a side repeater. I also decided, in the interests of safety, to fit an extra high level brake light and chose a simple LED one mounted above the petrol tank. It is bolted to a stepped aluminium bracket that is clamped under the fuel tank straps. In this way no extra holes had to be drilled anywhere. The original indicator switch was similar to those found on Morris Minors and positioned to the right of the Speedometer. My car had always had a stalk indicator switch fastened to the steering column and I opted to keep that as more practical and use the hole for the indicator switch for a water temperature gauge.

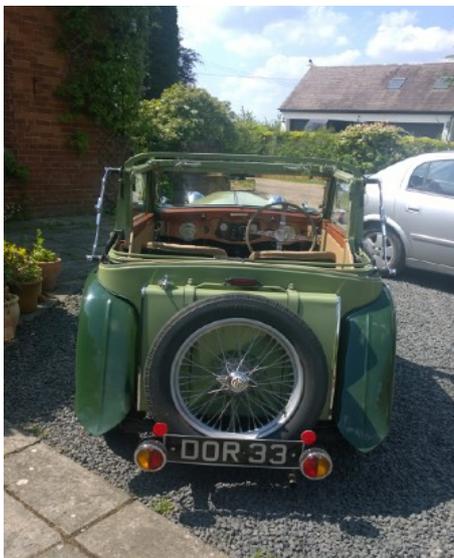
A photo showing the rear light set up including the high level brake light

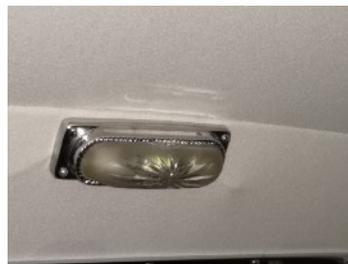
The interior light attached to the rear hood bow and a close up of the same. My car was missing the interior light and the late Derek Hopper had a spare one which I bought from him. When he had finished building a couple of Tickfords himself Derek was very helpful with various patterns and measurements as well as odd bits like this light.

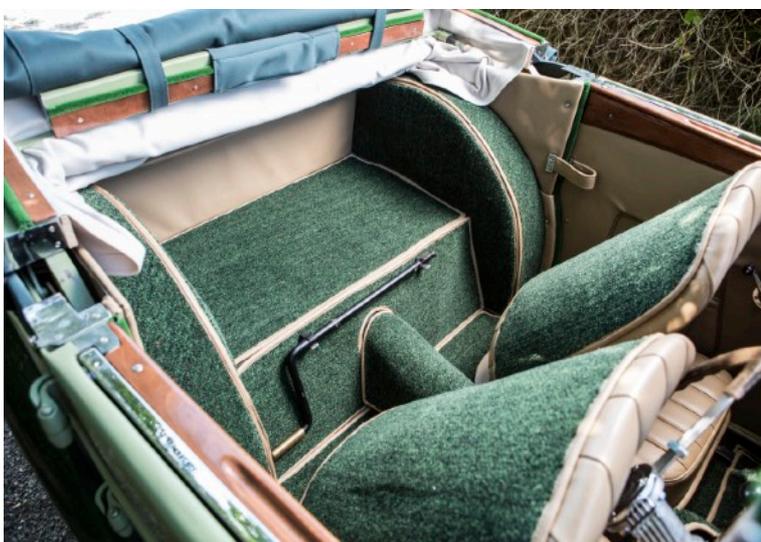
Interior trim behind the seats

Apart from the seats and door cards my car was missing all the interior trim. There are trim panels around the rear of the car and there are carpets covering the rear wheel

arches, the battery cover, the heel board, the transmission tunnel, the floorboards, the gearbox cover and the front side foot wells. There was also a gaiter for the handbrake. David Cale who skinned the body tub for me mentioned that he had done some work for someone with a TB Tickford and I was able to get in touch with the owner Clive Brook. By good fortune he had stripped the trim out of the car and I was able to take photographs and cut out paper templates of all his trim pieces. In all there were 17 different trim pieces and this gave me a good guide as to what goes where.

Taking these patterns as my starting point I cut out the trim panels to fit the rear of my car and covered them in PVC to match the leather used for the doors and seats. I also cut out all the carpet pieces for the rest of the trim and sourced an MG heel mat from NTG. I eventually got these to fit well and took all the carpet pieces to Dean Russell for him to bind the edges, stitch in the heel mat, insert lift a dot fasteners for the floor carpets and make up a handbrake gaiter. The original foot well arrangement was a single piece of carpet each side stuck to the well and with a large pocket on the passenger side. I decided to alter this arrangement and carpet just the front part of each well held in place by a vinyl covered trim piece at the rear of each well with a pocket in each.

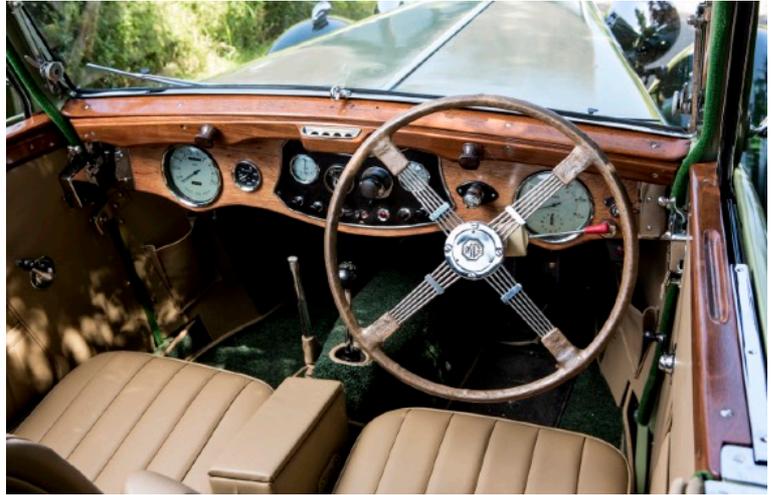
Front interior trim

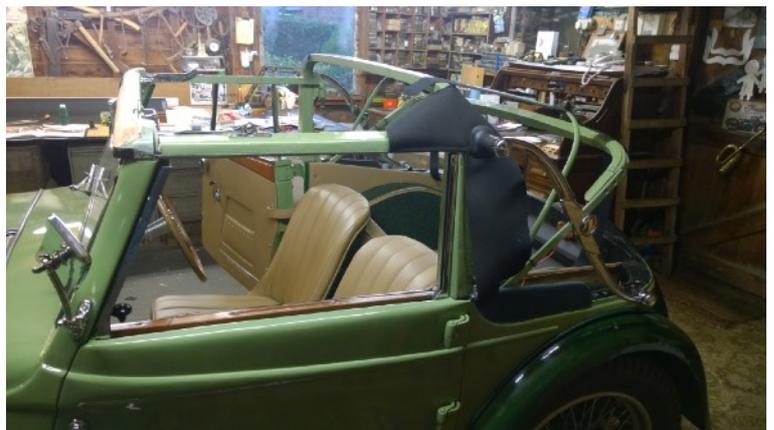
Setting up the hood bows and tension wires for the hood prior to cutting out the fabric.

The following week he asked me to call in and talk through various aspects of the work, in particular the tensioning arrangement for the front part of the hood. We worked out the best way of getting the tensioning wire fitted, the correct positioning of the hood bows and the desired line of the hood over the top of the door windows.

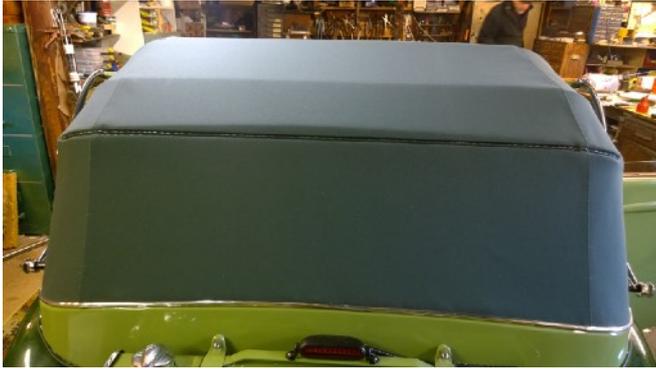
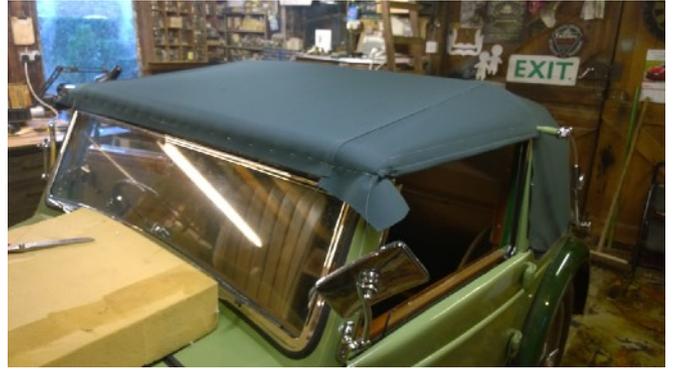
We talked through the best line for the front of the hood and how to seal it on the windscreen and also how the straps would work to hold the furled front section of the hood in place when in the coupe de ville position.

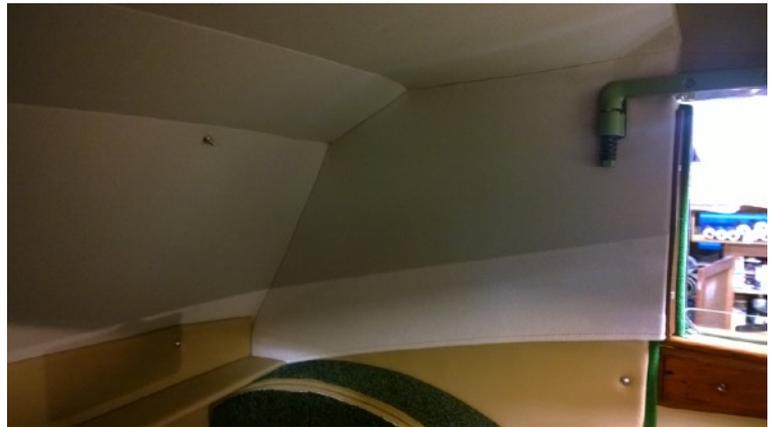
The fully-lined interior
