The Flex Plate and Vertical Drive.

An article Inspired by Bill Bollendonk who is negotiating his way through an L rebuild.

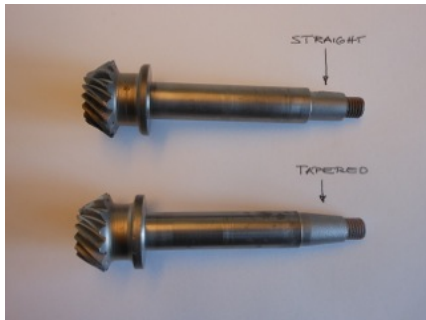
The vertical bevel geared shaft that drives the camshaft comes in two flavors: one with a straight shank on which the fork is assembled and the other with a tapered end to engage a tapered bore in the fork. Most engine builders have abandoned using the straight shank variety because they are prone to failure unless assembled with a heat shrink fit. The bevel gear with a tapered end, assures a steadfast attachment to the fork, however, it requires a thoughtful review of the liabilities on assembly.

1. The tapered bored forks also come in many varieties, the consequence of which is a varied position on the bevel geared shaft. This, in turn, affects the acceptable clearance with the flex disk on assembly: a fork that protrudes vertically too far will flex the coupling down; a fork that falls short of the disk will warp the coupling vertically up on assembly.

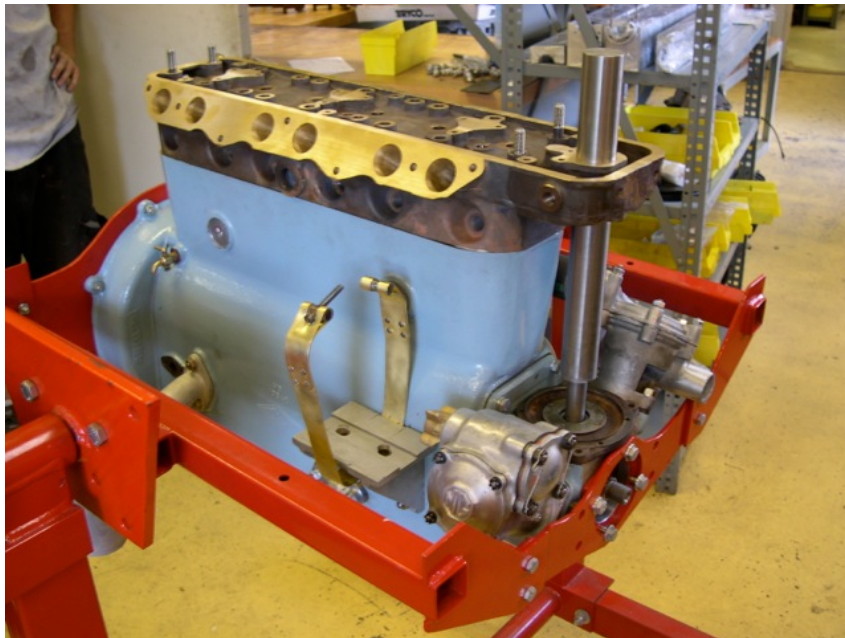
For the practice as just described to have merit, it is imperative that the vertical drive and the generator have a common axis. This procedure is described in Blowers Manual and elsewhere and employs a fixture similar to what is pictured below.
