“A BLOWN PISTON”

(or “The burdens of a Twin Cam owner”)

By David De Saxe

First published in “Safety fast!” March 2010

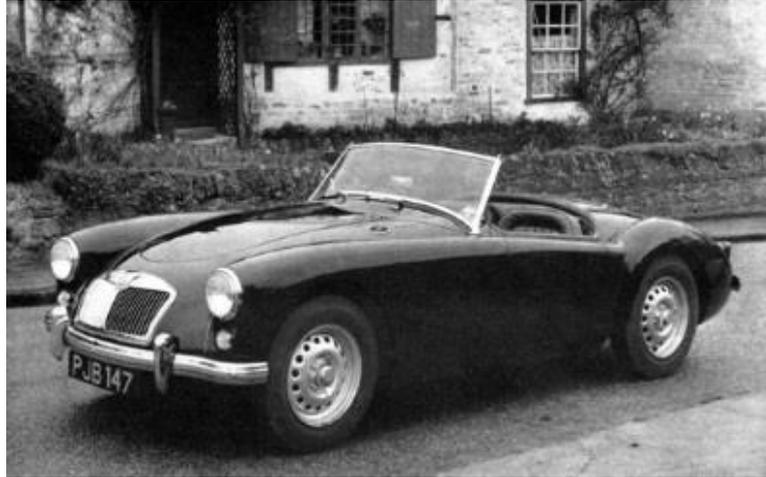
John had given the head and the valves, stems, guides and buckets a thorough examination before I had the machining done, and his view was that all components looked good with none needing replacement. The question that remained, therefore, was what had caused the blown piston. None of this is rocket science, though we all know the phenomenon caused the engineers at Abingdon to scratch their heads when it happened with alarming frequency with works competition cars as well as those belonging to customers. The cause can be classified in only four ways: incorrect ignition setting; wrong fuel or too lean a mixture; metallurgical failures; and incorrect engine assembly – e.g. valve settings or timing. I’m sure the chaps at Abingdon were able to eliminate the last two, so burnt out pistons must have been caused by ignition timing or fuel problems.

My engine is the later, lower compression type. Using the awful stuff that passes for petrol nowadays, plus a manganese-based lubricating and octane-raising additive (Miller's VSP) at each fill-up, I have always set the ignition at 3 degrees before TDC. This compares with the factory recommendation of 8 degrees BTDC using 101 or 99 octane petrol. I believe the retardation of 5 degrees to have been reasonable, and I certainly never experienced any pinking or running-on. If there was any reduction in performance I wouldn't have noticed it. Equally, I always set the twin SUs over-rich – though how much over-rich they need to be is a moot point. So what had I done wrong or failed to do?

On the very last page of the ignition section (section B.14) of the workshop manual there is a sinister warning: I quote the final sentence: "If the distance between the two limits exceeds 5/16 in. (8 mm.) the distributor drive gears must be renewed before a new distributor is fitted." In other words, ignore that at your peril. John lent me a suitable pointer he had made to gauge the amount of movement in the distributor drive shaft. The measurement was somewhat in excess of the tolerance given in the book, so, heeding the sinister instruction, I told John, who told Peter, who said: "There's your problem, then". I have to say that to question such a statement from a Twin Cam expert of Peter Wood's massive experience would be foolhardy in the extreme, but I confess that inwardly I was thinking that the lower compression engine would permit much more tolerance in ignition timing, and if the shaft wobbled a little bit more than it should, would that really cause too much heat at the top of the cylinder? People I asked said their distributors had quite considerable backlash and it didn't seem to matter. I kept silent, of course and Peter was able to supply new distributor drive gears (the price of which caused severe wincing). I got my machine shop to fit the gears to the distributor; then, with further gritting of teeth, I had it rebuilt by Holdens. On refitting the distributor, I rechecked the play which was now well within tolerance.

John Tofts had suggested using Thackery washers when refitting the carbs to the manifold. *Thackery-Schmackery*, I thought, because I wanted to get on with it and see if the engine fired. As I said earlier, it did, and I thought nothing further of John's advice. (I should here note that John's Twin Cam is fitted with twin Webers, which helped me to think nothing further). And then I read the Twin Cam Group's book "The First 50 Years". In particular, I read Bill Spohn's article on page 74. I then re-read it – twice. I implore you all to do likewise, if you haven't already done so and acted appropriately. I'm not saying that badly timed ignition doesn't matter, but I am saying that what Bill writes about carb floats sticking on the central post and causing a lean mixture seems far more likely to be the cause of piston failure.

I desperately needed expert advice and assistance, and none was more welcome than that of John Tofts (who owned the car for many years before it was mine), and Geoff Barron, both of whom gave up more time than I believe they really had available to come to my house and work with me to install new pistons and put

The remedy is unbelievably simple – and unbelievably cheap. For about £14+ VAT you can get the complete kit to cure the potential problem. Order the parts from Eurocarb of Reading (0118-943-1180 or www.dellorto.com). As the website suggests, Eurocarb are Dellorto (and Weber) specialists, but the carb mounting kit adapts for SUs. You can order on-line for next day delivery. You need 2 Misab 47mm. Spacers (these are thin alloy plates surrounding a lightly protruding O-ring; you'll need to elongate the fixing holes a fraction to fit the wider spacing of the manifold studs); 8 Thackery washers (these are the double wound type); and 8 nyloc nuts. (The photo shows only four nuts and washers, but you'll need eight).
