Side screen brackets on the MGA Roadster

Geoff Kirk

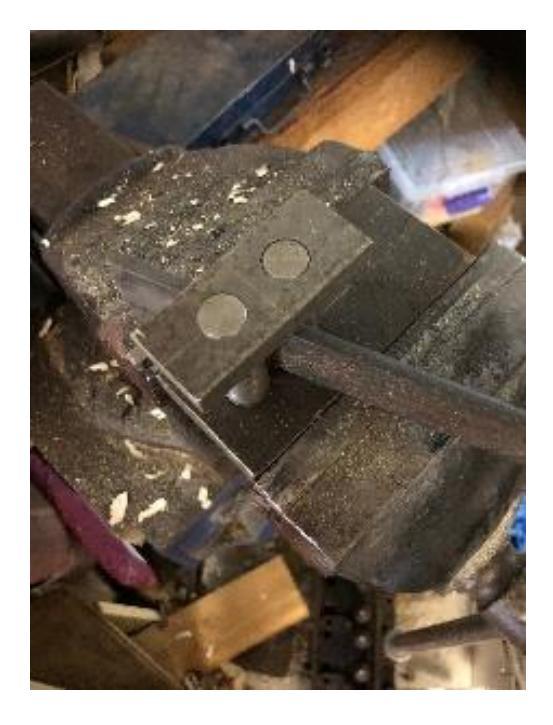
Initial trial fit showed that the aluminium rail was too tight to the cockpit rail and also didn't clear the inside top edge of the door; the fit to the windscreen was poor being tight at the lower point and considerably out of alignment in both vertical axis.

On comparing with both the original fabric screens and the original "Weathershield" ones it is quite clear that the front brackets on the new alloy screens are different in shape.

My first attempt at rectifying the new brackets was to re-form the shape using a "scroll tool" created from two pieces of round bar socketed and welded to a base. The resulting bracket was a better fit but still forced the bottom edge too tightly onto the leather covered cockpit rail and didn't alter the fit to the front edge / windscreen.

I also noted that the bracket would catch the windscreen grab handle which apart from damage to the chrome would not allow the screen to ft snuggly into the windscreen edge which the original screen did. At this point I decided that to make new brackets was the solution.

The process to make new screen brackets started with the correct section steel, 5x30 & 5x13 BMS black mild steel has that rounded edge, like the originals,) . Nick Moore, blacksmith at Market Weighton, had the section in stock which he kindly gave me a couple of short lengths.

I first bent the swan neck of the door strap using the scroll tool and heat. This created a similar form to the original ones, then a slot was drilled and cut by hand, (I haven't got access to a milling machine to form the recess to accommodate the knurled doorknob).

The frame part of the bracket was then bent to the shape of the original, the top of the bar clears the grab handle on the screen.
